DIAVIK DIAMOND MINES (2012) INC.

2014 Wildlife Monitoring Report

Reference Number: 1406208-1393-R-Rev0-6000

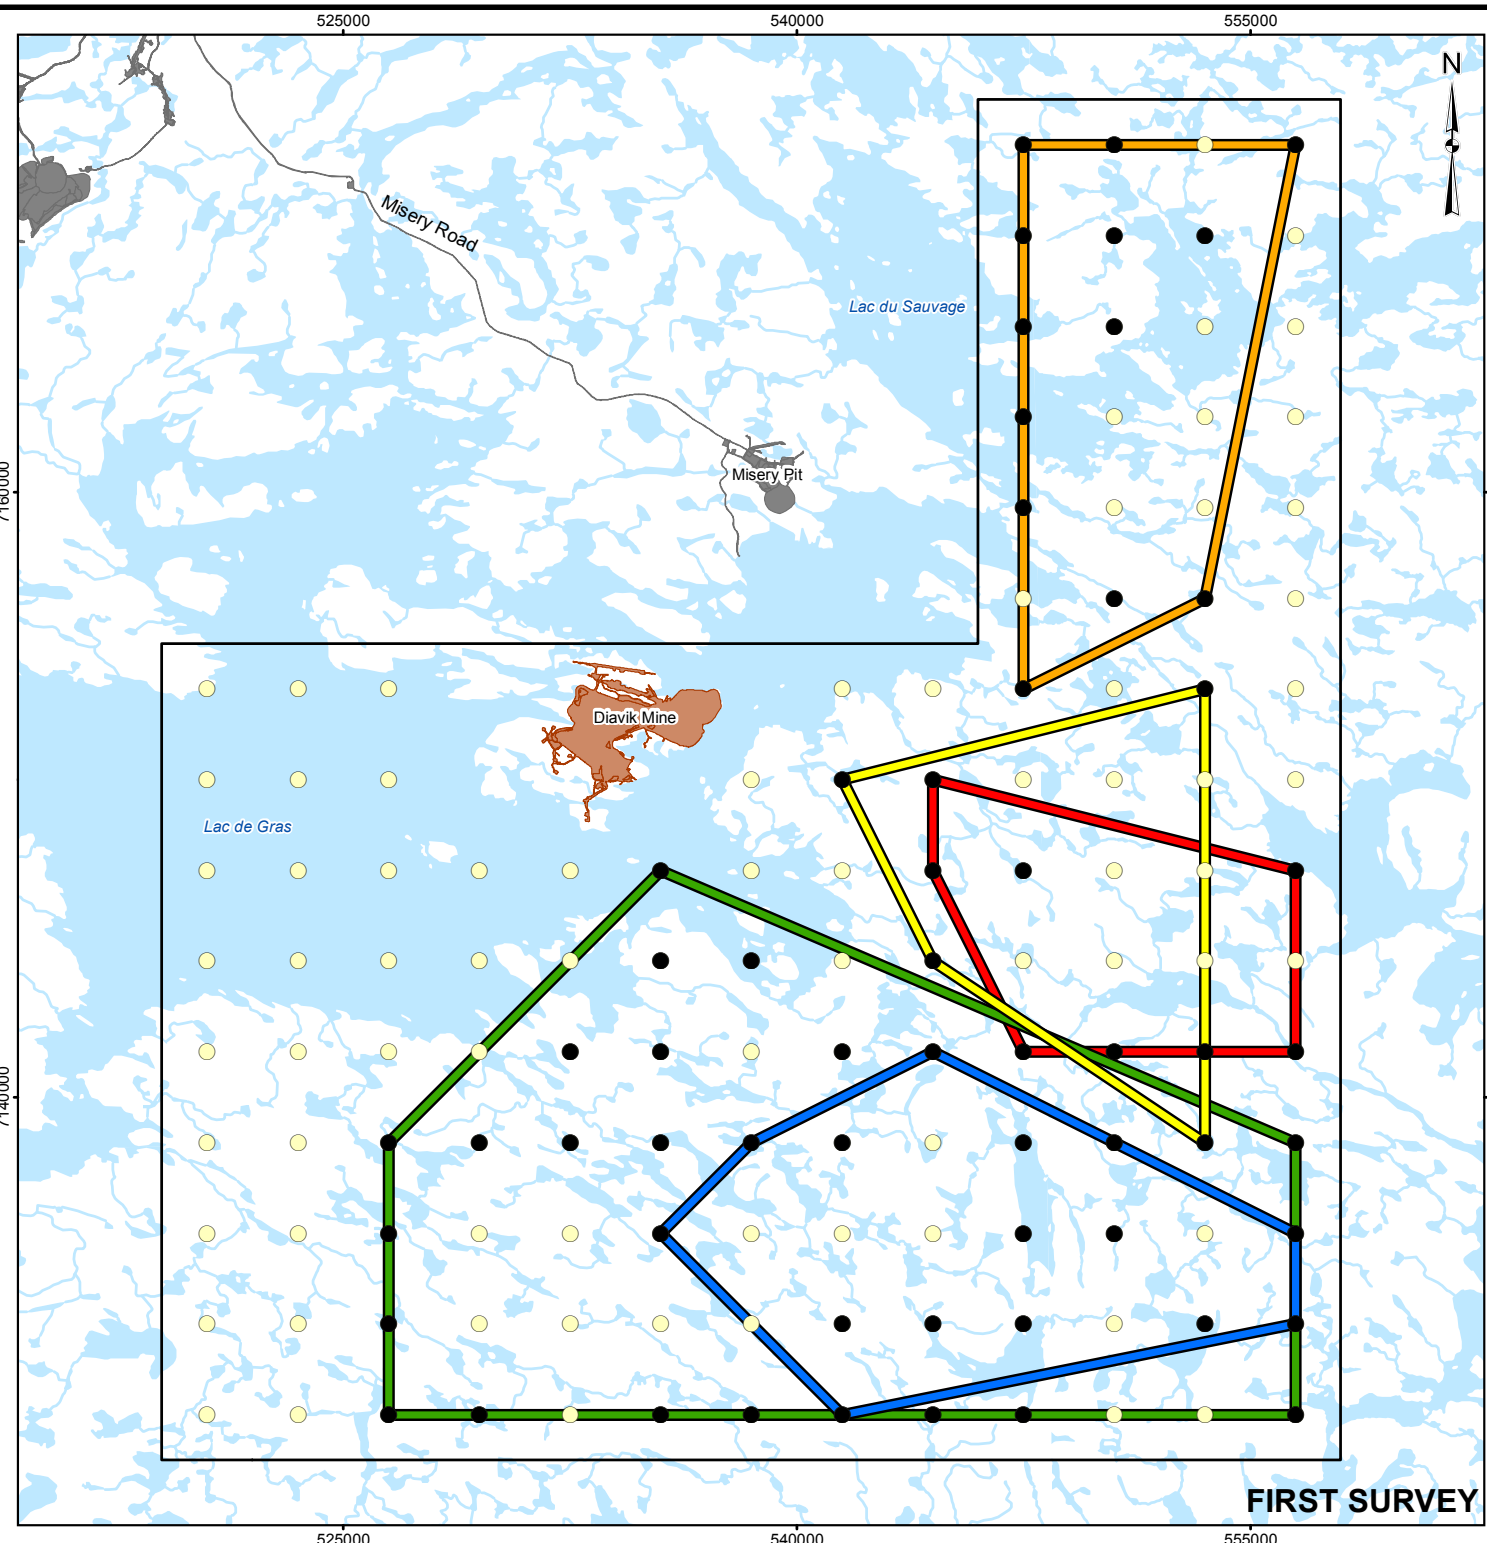
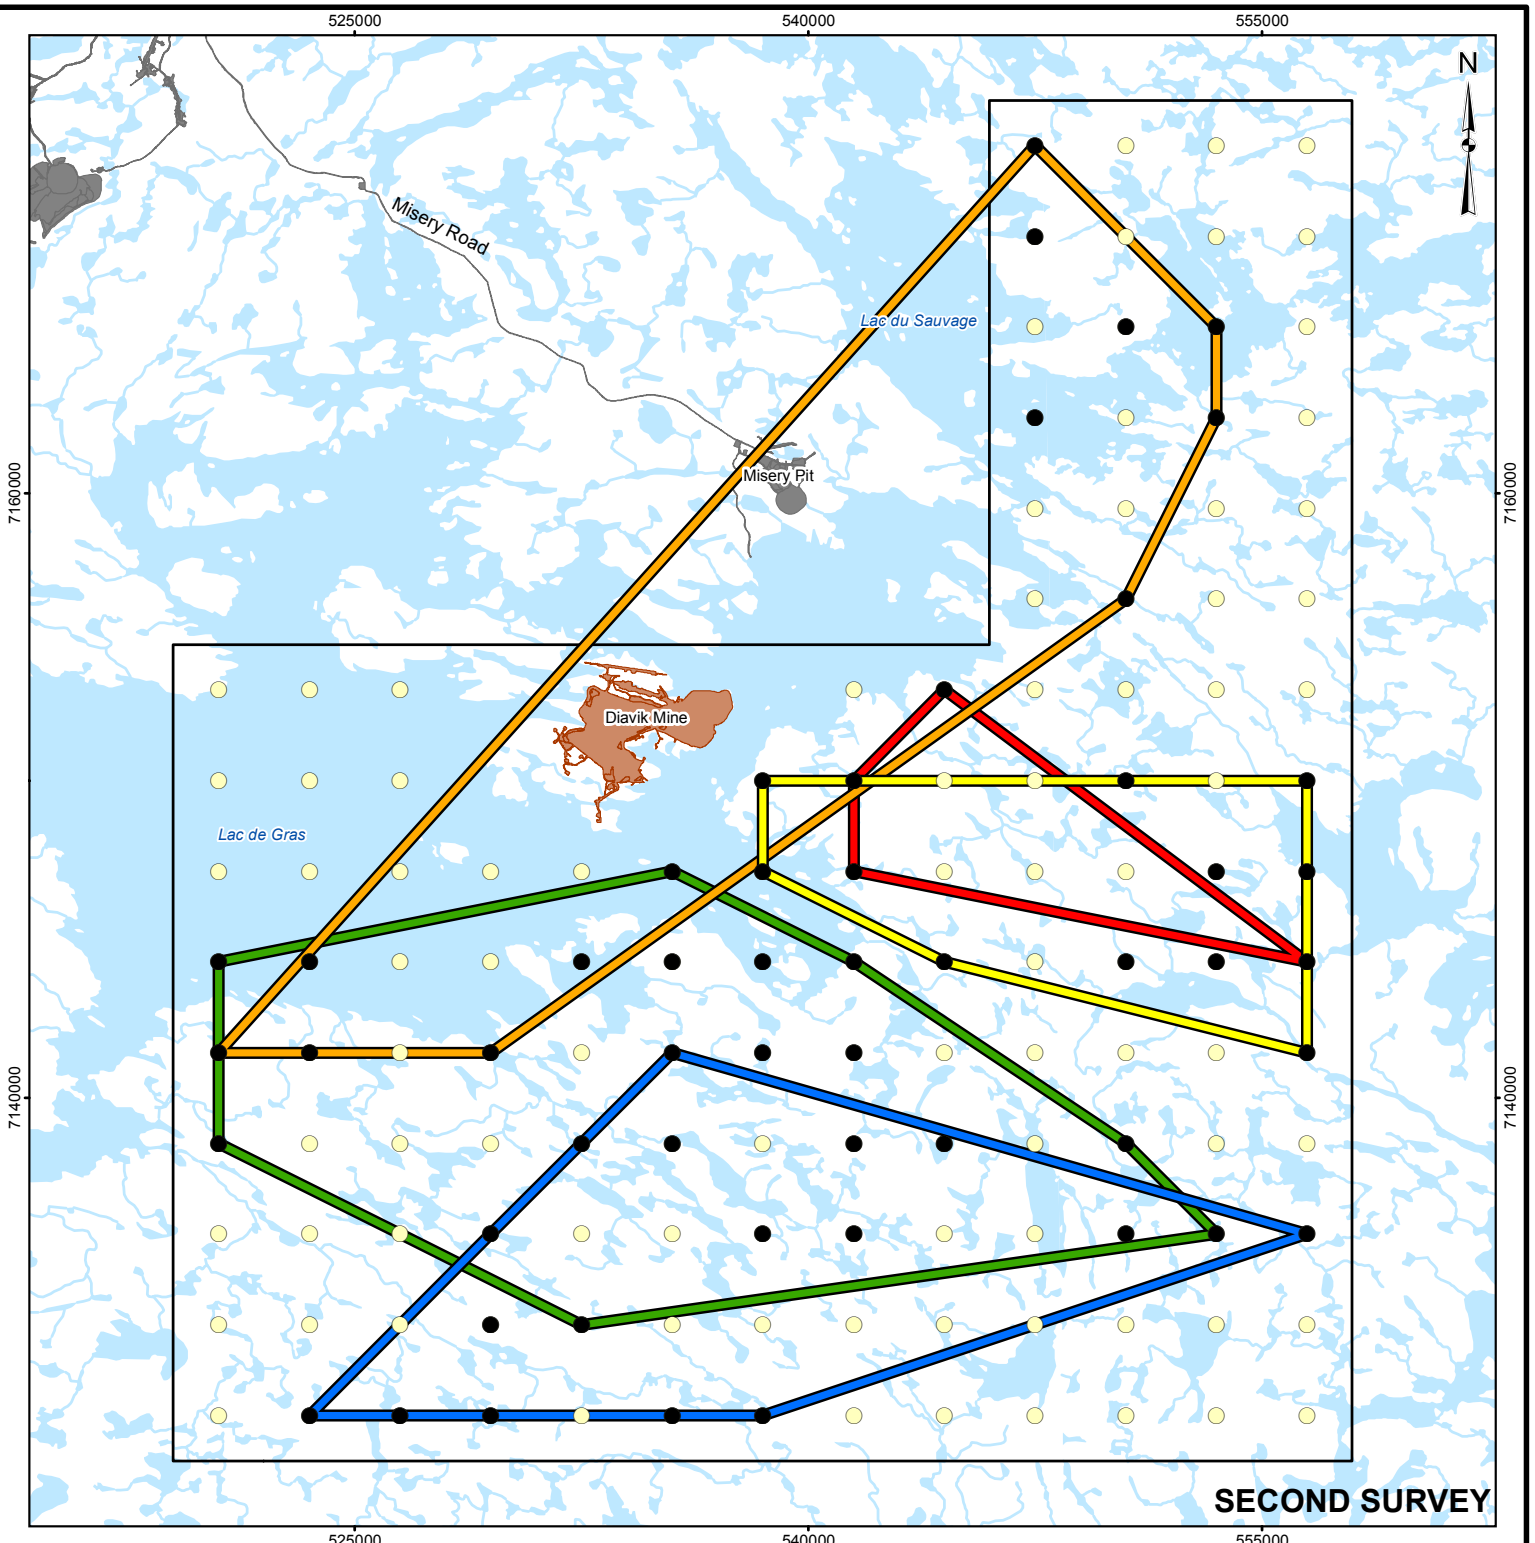
PROJECT	Rio Tinto		DIAVIK DIAMOND MINES INC.
TITLE	CONVEX HULL POLYGONS FROM DETECTION OF WOLVERINES IN THE FIRST AND SECOND SURVEYS, 2014		
	PROJECT	1406208	FILE No.
	DESIGN	DC	23 Feb. 2015
	GIS	UW	20 Mar. 2015
	CHECK	DC	20 Mar. 2015
REVIEW	JV	20 Mar. 2015	FIGURE: 8

FIRST SURVEY

SECOND SURVEY

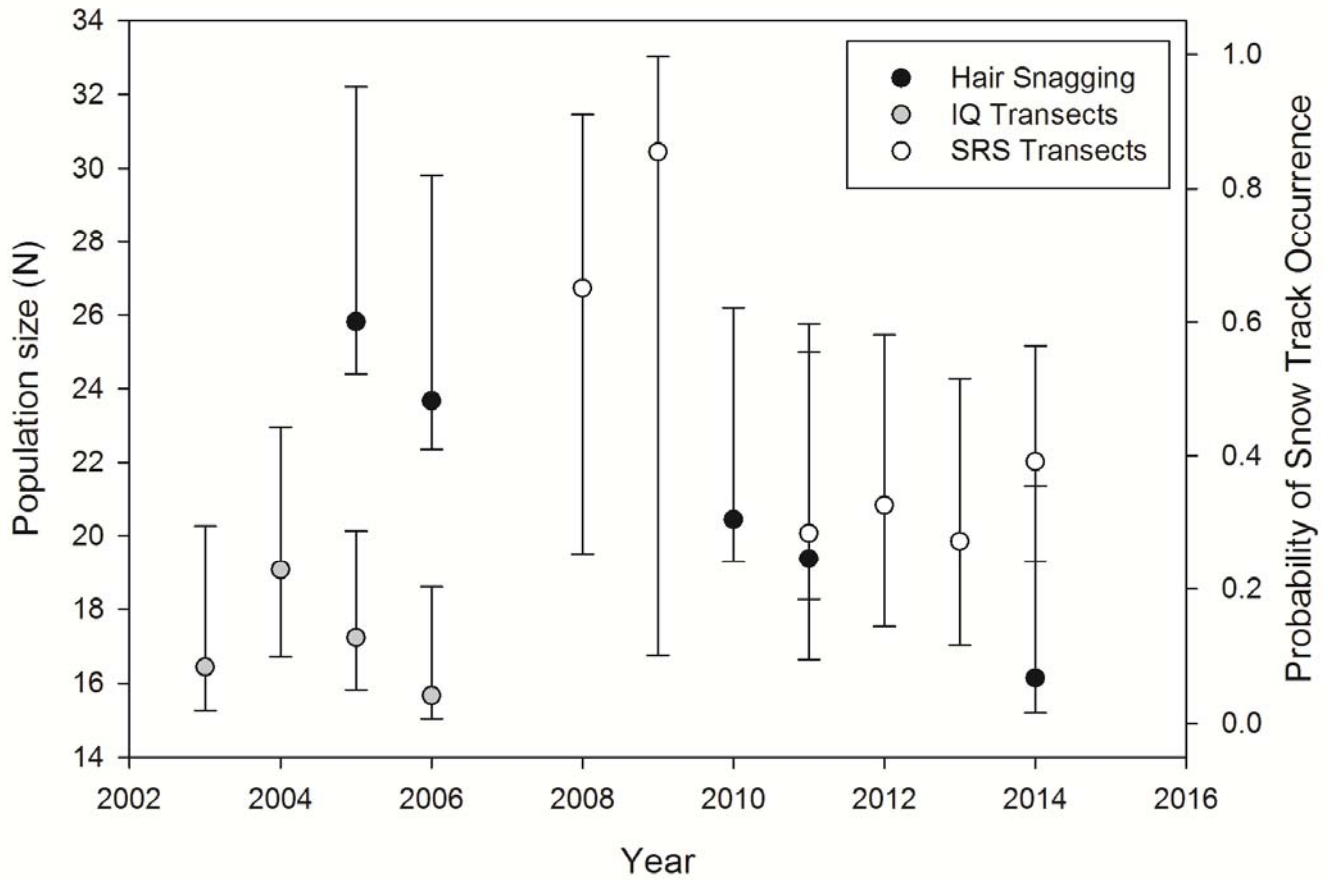
Figure 9: Annual Estimates of Wolverine Population Size (95% CI) from Mark-recapture and Probabilities of Snow Track Occurrence

Note: IQ transects refers to "Inuit Qaujimatjuqangit" and SRS transects refers to Stratified Random Sampling Monitoring Designs.

The visual comparison of annual results from the hair snagging and snow track programs is presented in Figure 9. The population size results of annual hair snagging of wolverines indicate a declining trend in the Diavik study area since the program began in 2005. The results of the snow track monitoring program also show a decline in the probability of snow track occurrence since 2008, when the study design was altered to increase statistical power by increasing sampling effort through stratified random sampling methods. Thus, there is general correspondence in the interpretation of trends in annual population size and the probability of snow track occurrence estimates generated by the current snow track monitoring program.

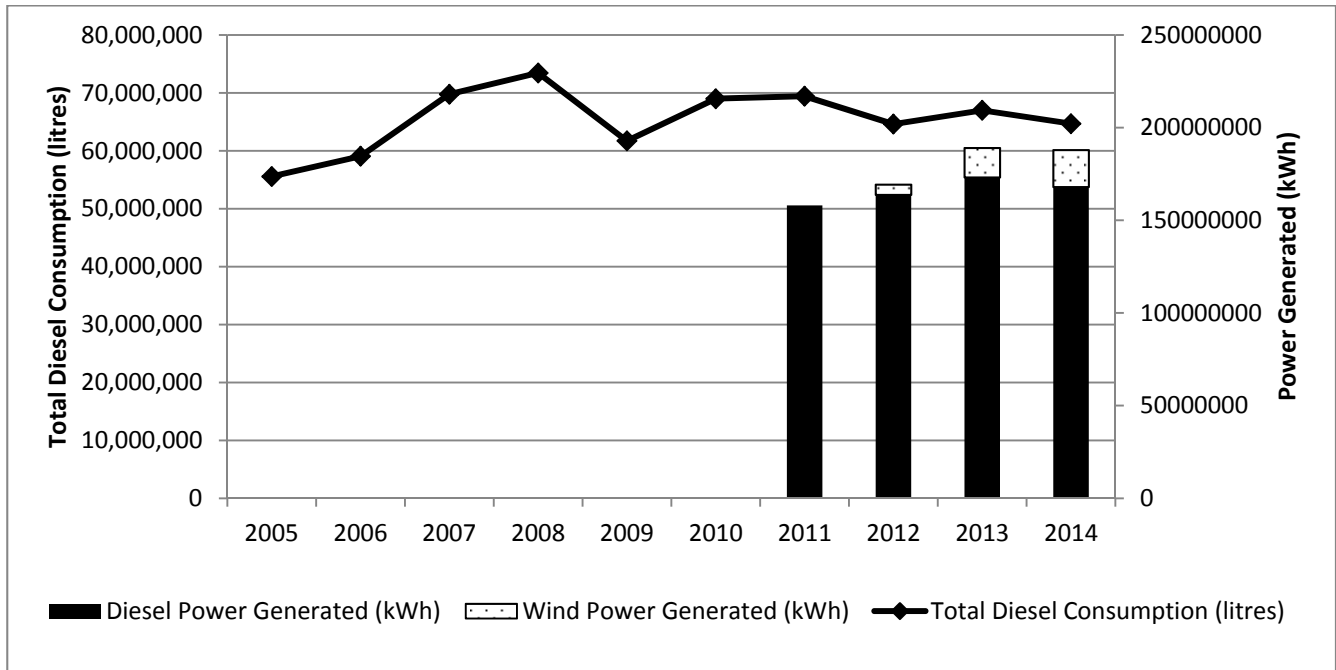
Figure 10: Diavik Power Generation and Diesel Consumption

The wind farm became operational on 28 September 2012 and it was predicted that it would reduce Mine diesel consumption by 10%, as well as greenhouse-gas emissions by 12,000 tonnes of carbon dioxide annually. During the first year of operation, the wind farm generated 15,893 megawatt hours (MWh) of power; which represents 8.4% of the total power generated in 2013 (Figure 10). In 2014, 10.5% of total power use was wind power, and the peak amount of total power used made up of wind power was 55%. The wind farm offset an estimated 14,068 tonnes of carbon dioxide emissions in 2014. From 2005 through 2014, the annual diesel fuel consumption at the Mine has ranged from 55,573,000 litres to 73,449,006 litres; the average annual fuel consumption is 65,431,004 litres.
