APPENDIX X
NORTH COUNTRY ROCK PILE CLOSURE DESIGN

Diavik Diamond Mine North Country Rock Pile Closure Design

Golder Reference Number: 1521339-1471-R-Rev3-7000

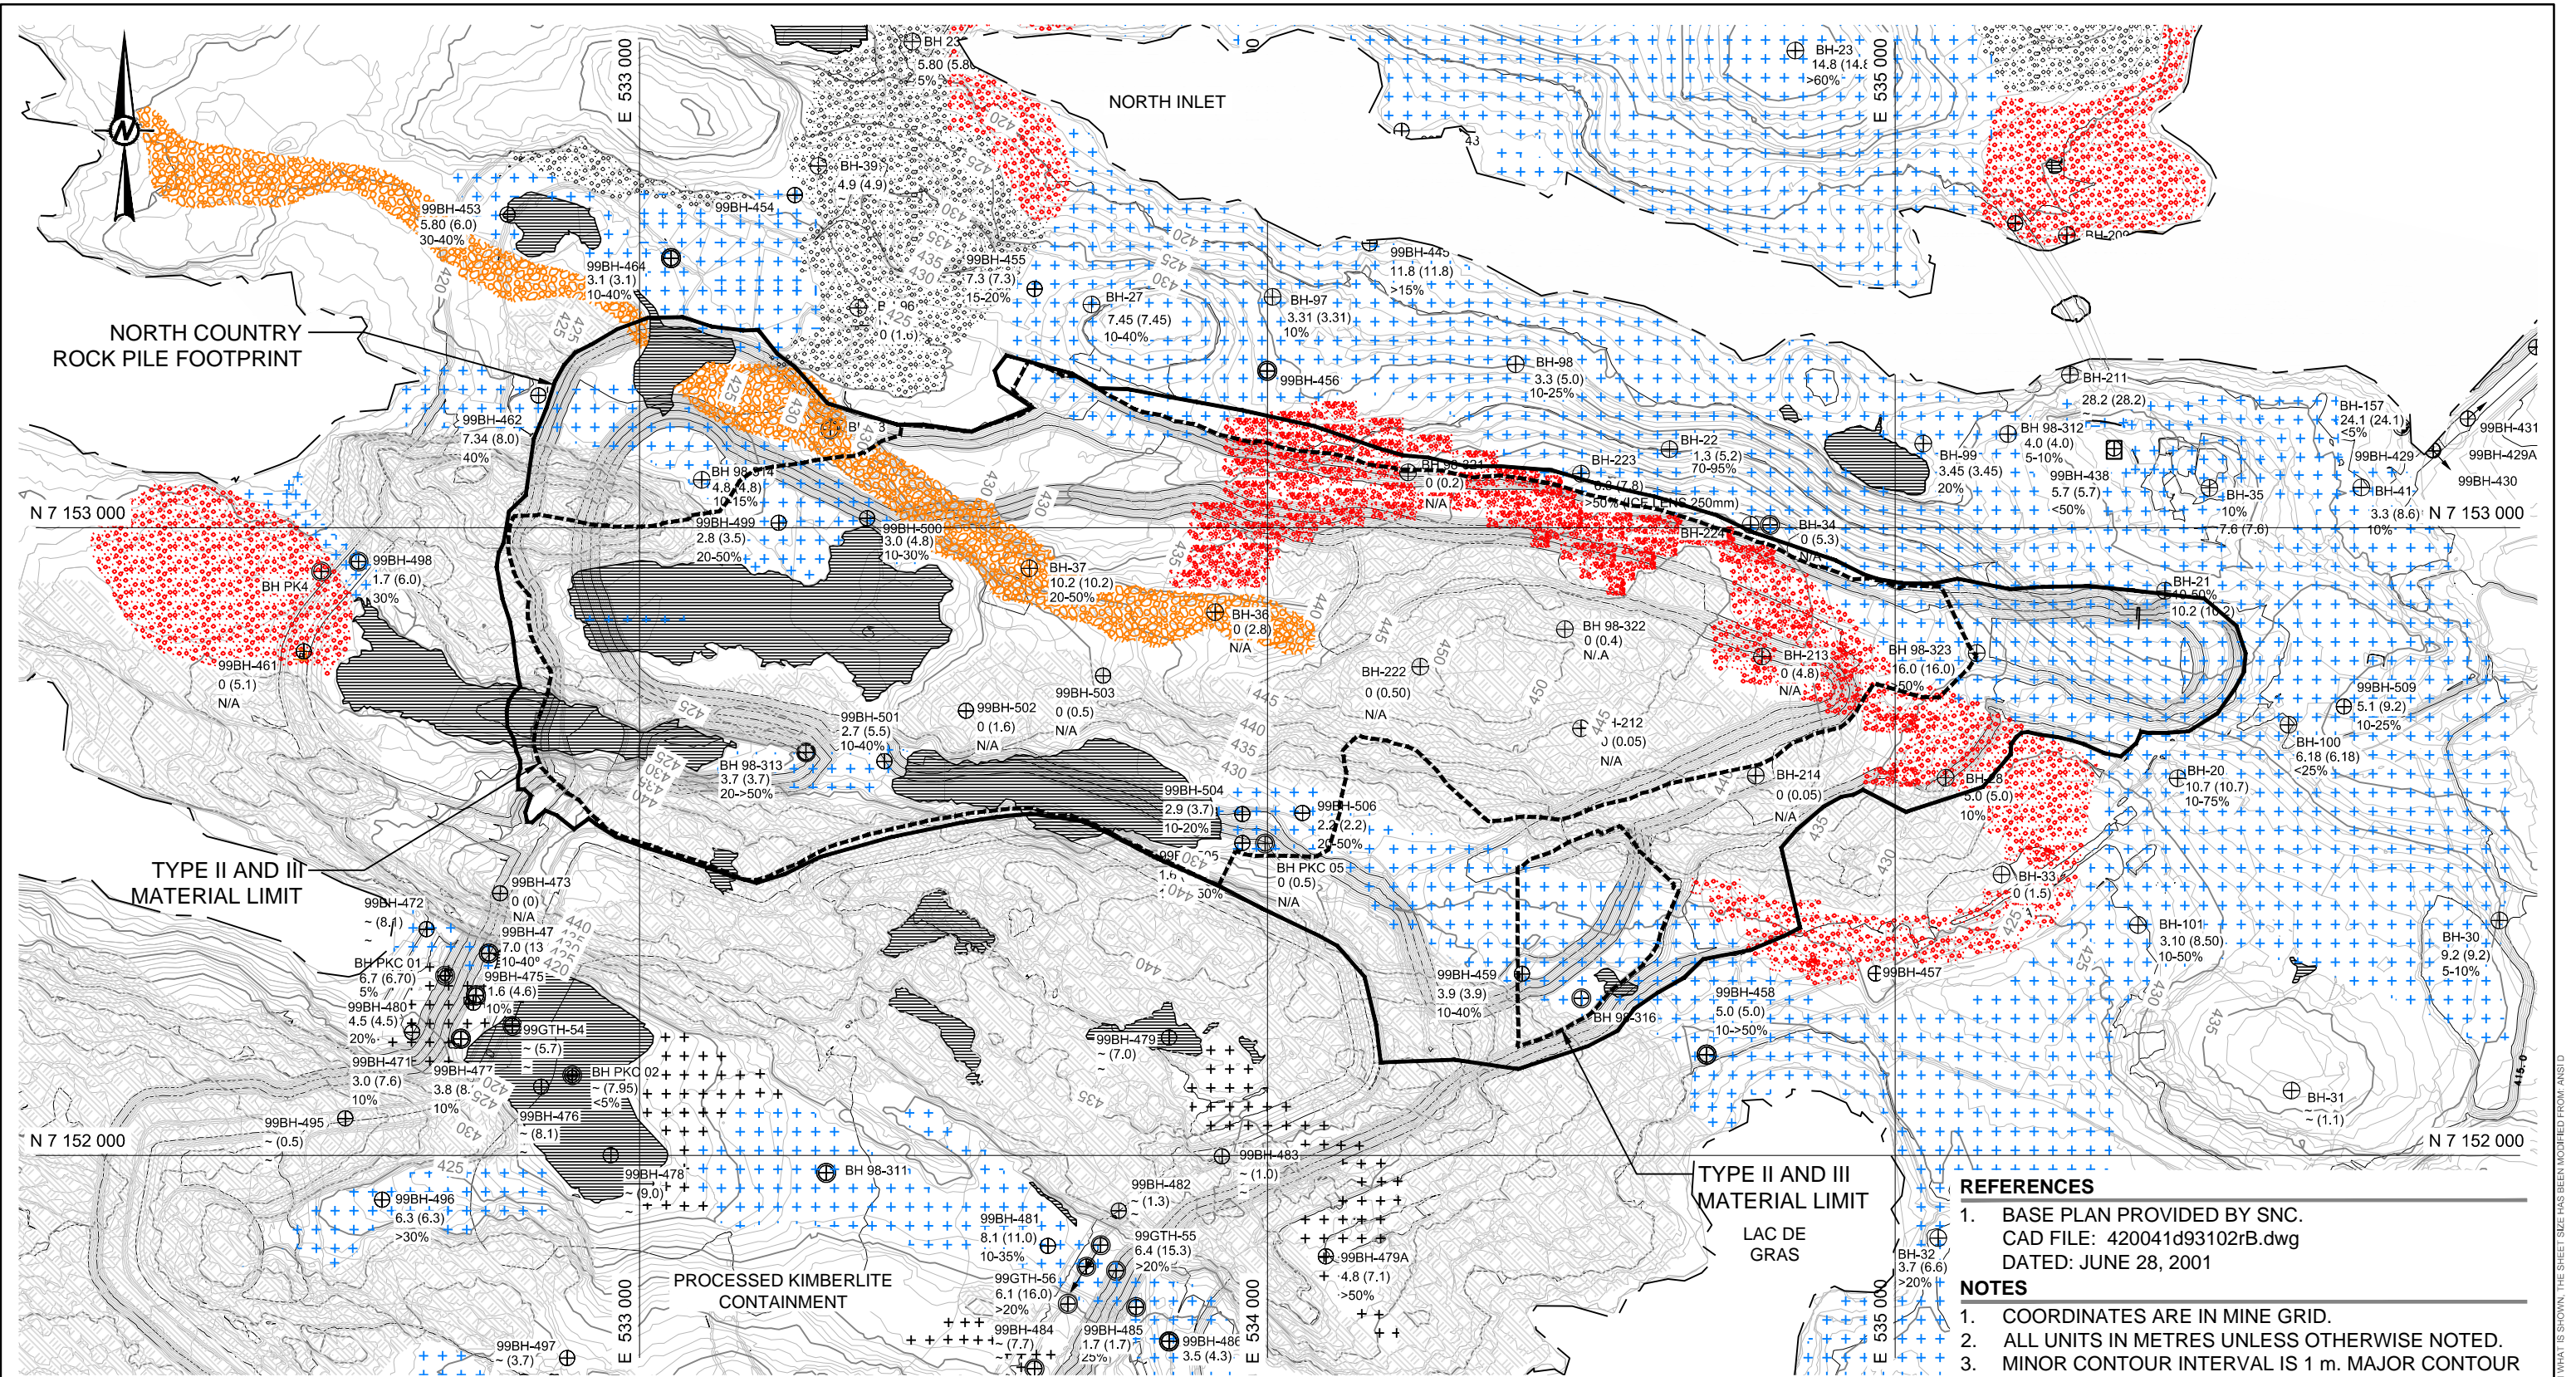
TITLE
 NORTH COUNTRY ROCK PILE
 FOUNDATION CONDITIONS

A plan of the NCRP area presenting the original ground surface topography and foundation conditions is included in Figure 3. The anticipated footprint of the NCRP after re-slope and prior to placement of the cover is also included in Figure 3.

Typical foundation conditions within the NCRP footprint include between 0 m and 3 m of organic cover, and 0 m to 6 m of primarily till soils overlying bedrock. Soils with greater than 10% visible ice content and 30% moisture content were classified as being 'ice rich' and are present on the island (NKSL 1999).

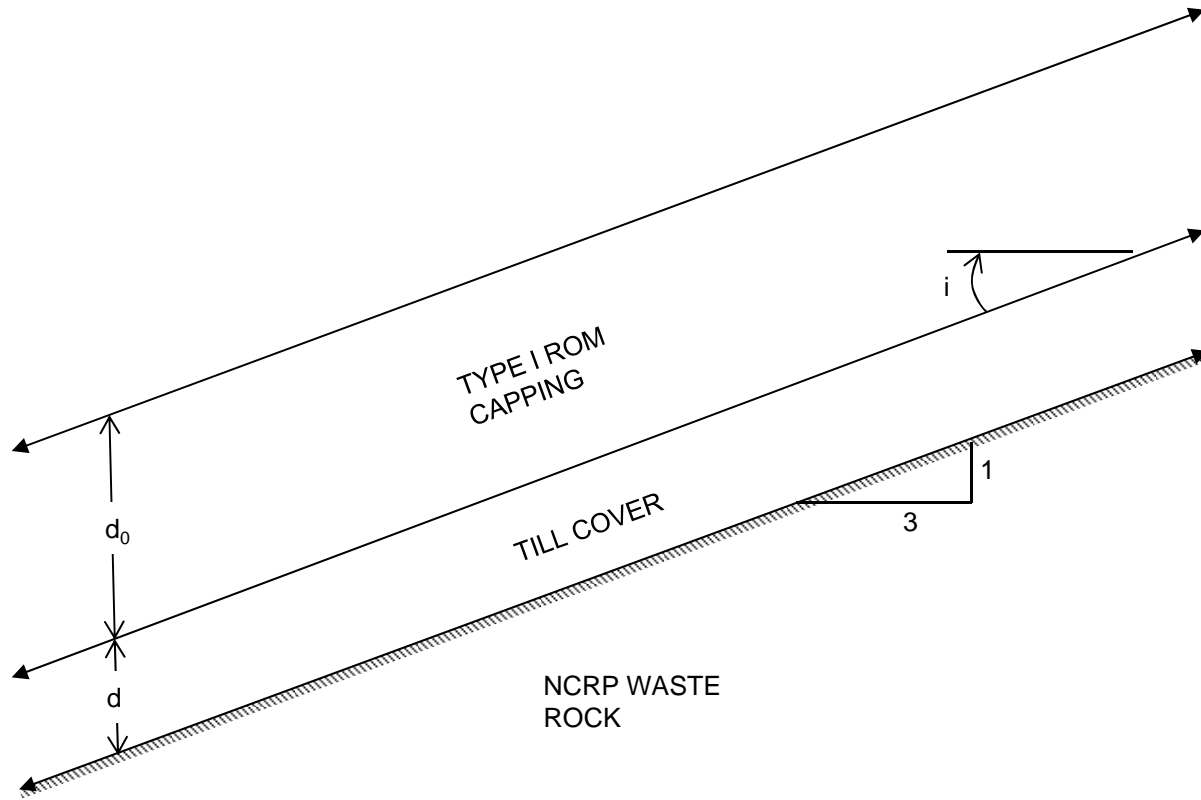
- Case 1: Stability of the 1.5 m till layer on a 3H:1V slope before placement of the Type I ROM capping layer (short-term condition).
- Case 2: Stability of the 1.5 m till layer on a 3H:1V slope after placement of the 3 m thick Type I ROM capping layer (long-term condition).

The results of analyses indicate that the design criteria for Factor of Safety are not met for the short term condition where the 3 m thick Type I capping layer has not yet been placed on the till cover. Therefore, if the till cover is left uncapped and allowed to go through freeze-thaw cycling, then some minor slippage of the till layer is expected to occur due to frost action. Maintenance works may be required during construction to re-grade the till surface and maintain a minimum 1.5 m till layer thickness. The design criteria for Factor of Safety are met for the final cover system configuration.

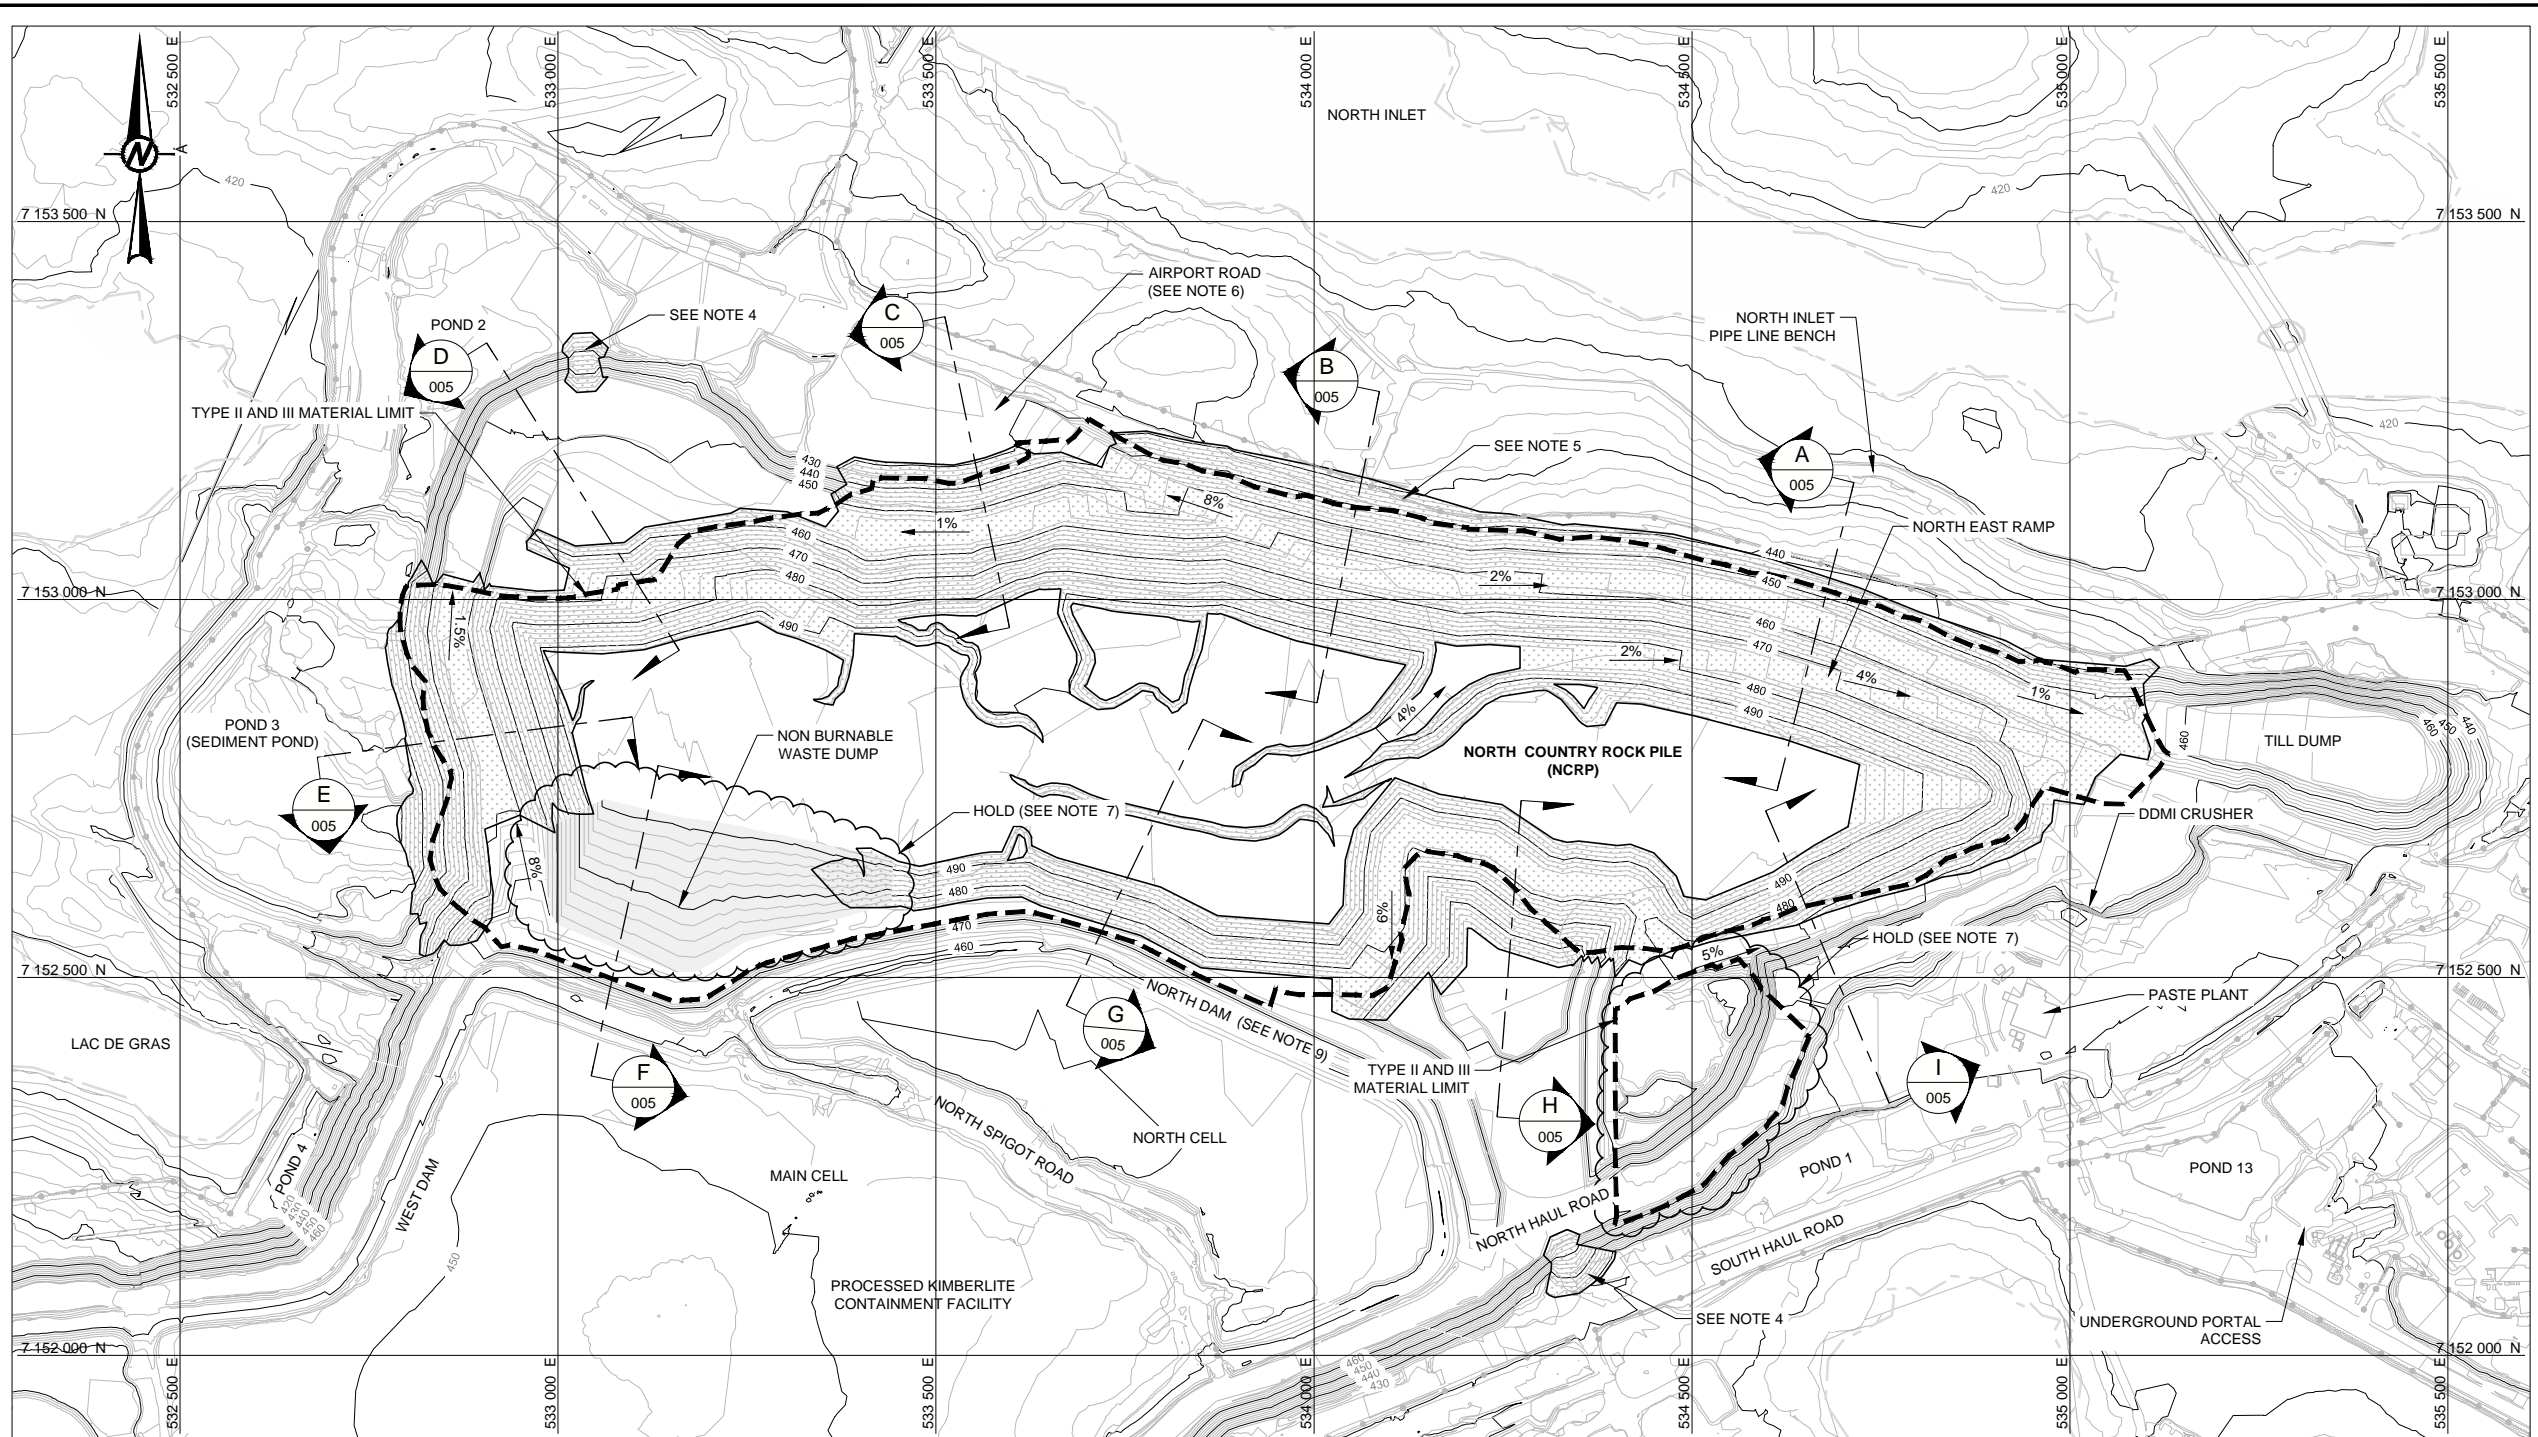
PROJECT DIAVIK DIAMOND MINE NORTH COUNTRY ROCK PILE CLOSURE Á	TITLE NORTH COUNTRY ROCK PILE - AFTER RE-SLOPE			
PROJECT NO. 1521339	PHASE / TASK 7000/7300	REV. 0	4 of 8	DRAWING 003

Areas of the NCRP containing waste rock with the potential for acid generation are re-sloped from angle of repose slopes to 3 horizontal to 1 vertical slopes and covered with a minimum 1.5 m (metres) of till and 3 m of non-acid generating (Type I) waste rock. The cover layer thicknesses and materials were designed by others and provided by DDMI as an input to the design presented here. The till layer function is to reduce infiltration and promote permafrost within the underlying waste rock. The till layer is designed as a permanently frozen layer (or permafrost aggradation layer), rather than as a low permeability layer. The 3 m waste rock capping layer serves as erosion and thermal protection over the till. Studies of thermal effects, geochemistry, seepage, surface water management, and environmental components of the NCRP closure design are referenced where available, and considered to be outside the scope of this report.

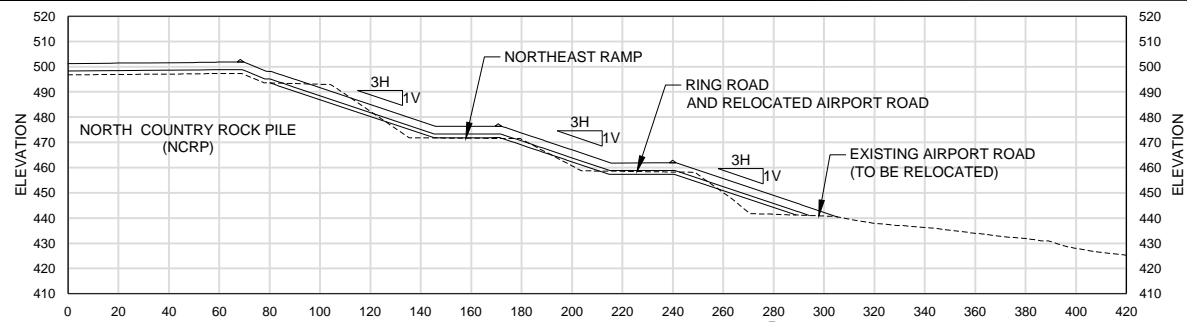
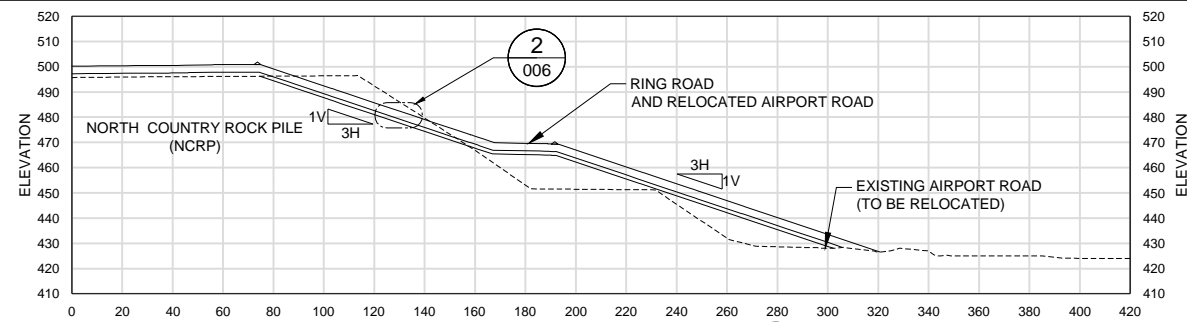
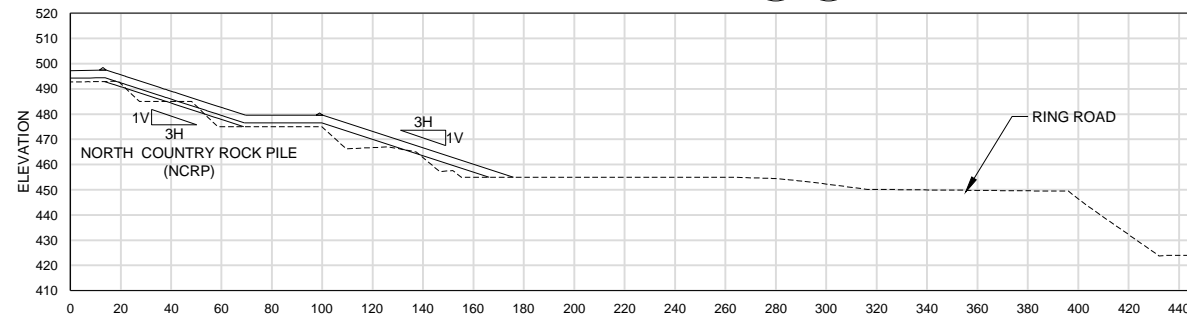
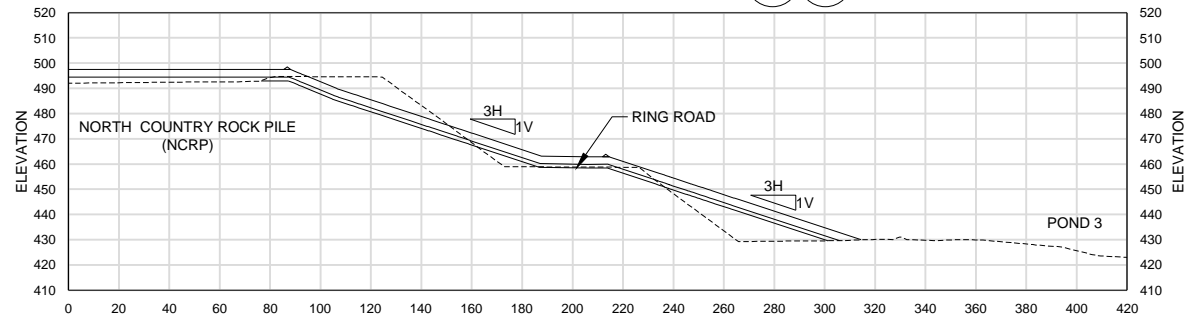
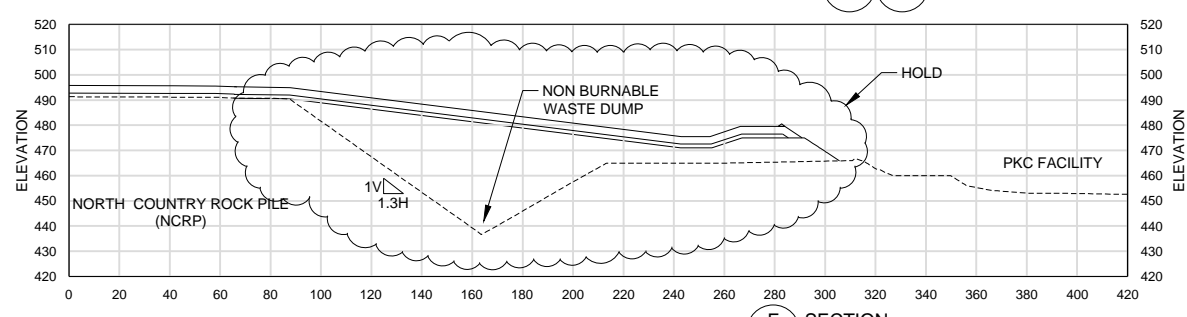
SCALE 1:1,500 SECTION A

SCALE 1:1,500 SECTION B

SCALE 1:1,500 SECTION C

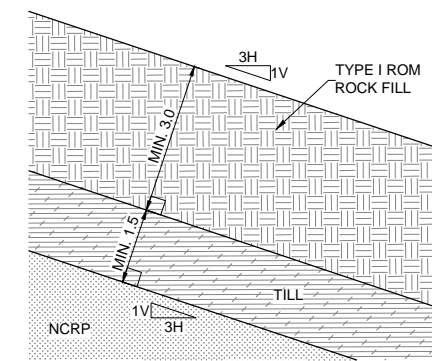
SCALE 1:75 **2** DETAIL - COVER SYSTEM
005

TYPE I ROM ROCK FILL
	TILL
	NCRP
	TRANSITION
	50 mm MINUS CRUSH
	COARSE PROCESSED KIMBERLITE
	ES2 COLETANCHE BITUMINOUS LINER

As described in Rio Tinto (2011) and Universities of Waterloo, British Columbia and Alberta (2010), the primary function of the till cover is to reduce infiltration and promote permafrost within the underlying waste rock. The till layer is not designed as a low permeability layer but rather as a permanent frozen layer (or permafrost aggradation layer) as classified in MEND (2012). The 3 m thick Type I waste rock capping layer serves as erosion protection and thermal protection of the 1.5 m thick till layer.

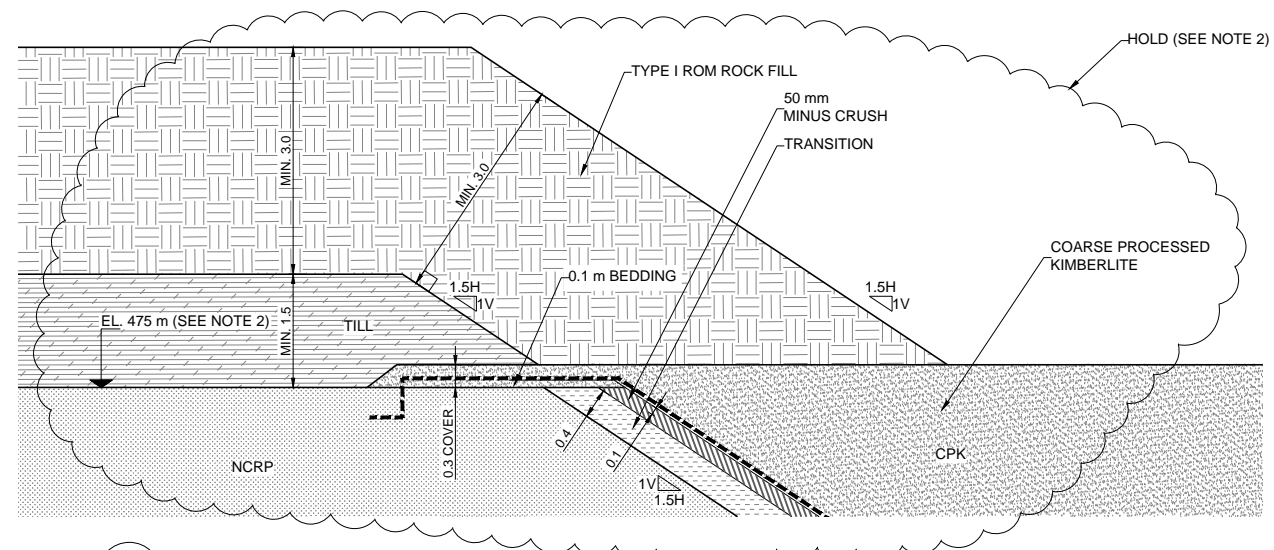
SCALE 1:50 **3** DETAIL - LINER TIE-IN
005

- NOTES**
- ALL UNITS IN METRES UNLESS OTHERWISE NOTED.
 - PKC FACILITY DAM RAISE ABOVE ELEVATION 465 m TO BE CONFIRMED. TIE-IN TO PKC FACILITY LINER TO BE CONFIRMED.

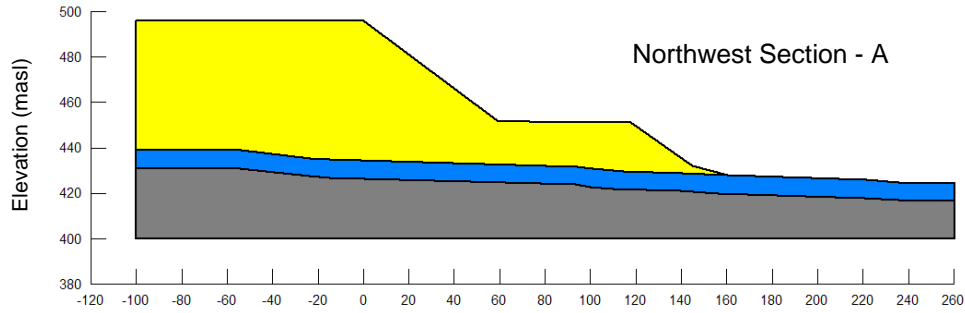
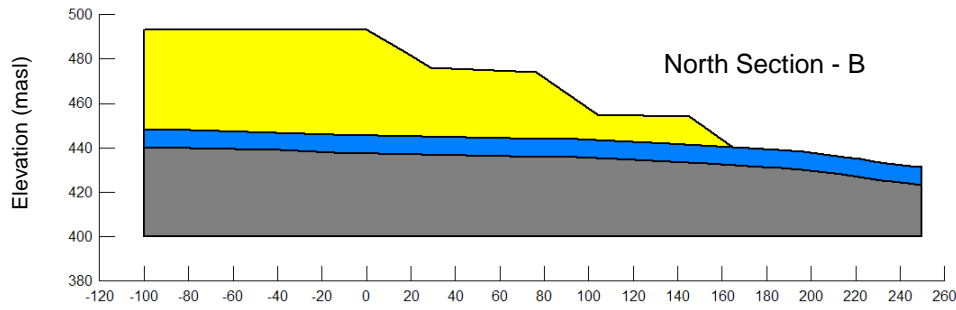
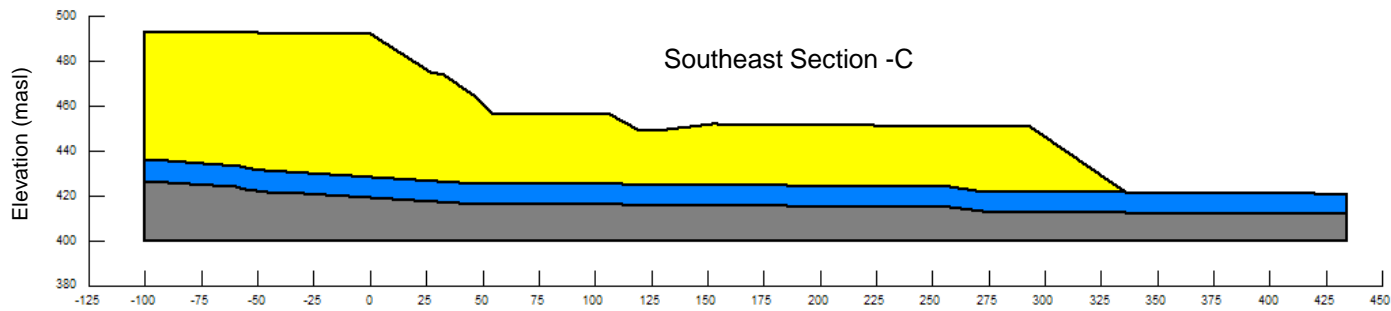
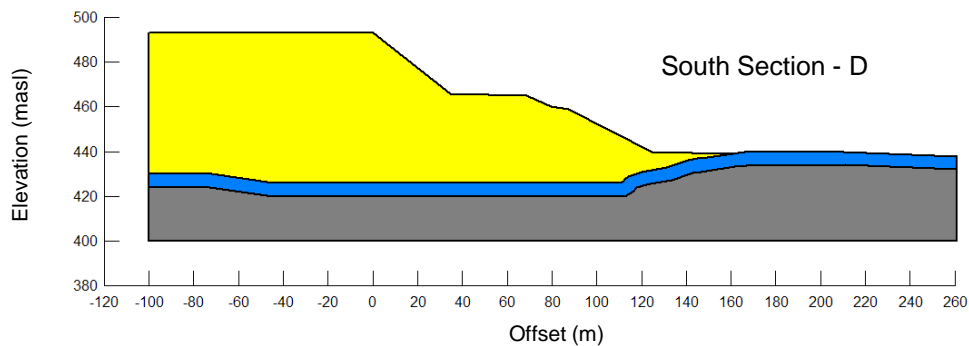
PROJECT No.	09-1328-0006		FILE No.	
DESIGN	BEW	16JUN09	SCALE	NTS
CADD	BEW	16JUN09	REV.	
CHECK	--	--	FIGURE 3	
REVIEW

Material	Unit Weight (kN/m ³)	Friction Angle, ϕ (deg.)	Cohesion, c (kPa)
Mine rock	19.6	45	0
Ice-rich soil			
Thawed	16	29	5
Partly thawed	16	24	0
Frozen T = -2°C	14	0	110
Frozen T = -4°C	14	0	150
Ice-poor soil			
Thawed	18	32	0
Frozen	18	0	400
Bedrock	Impenetrable

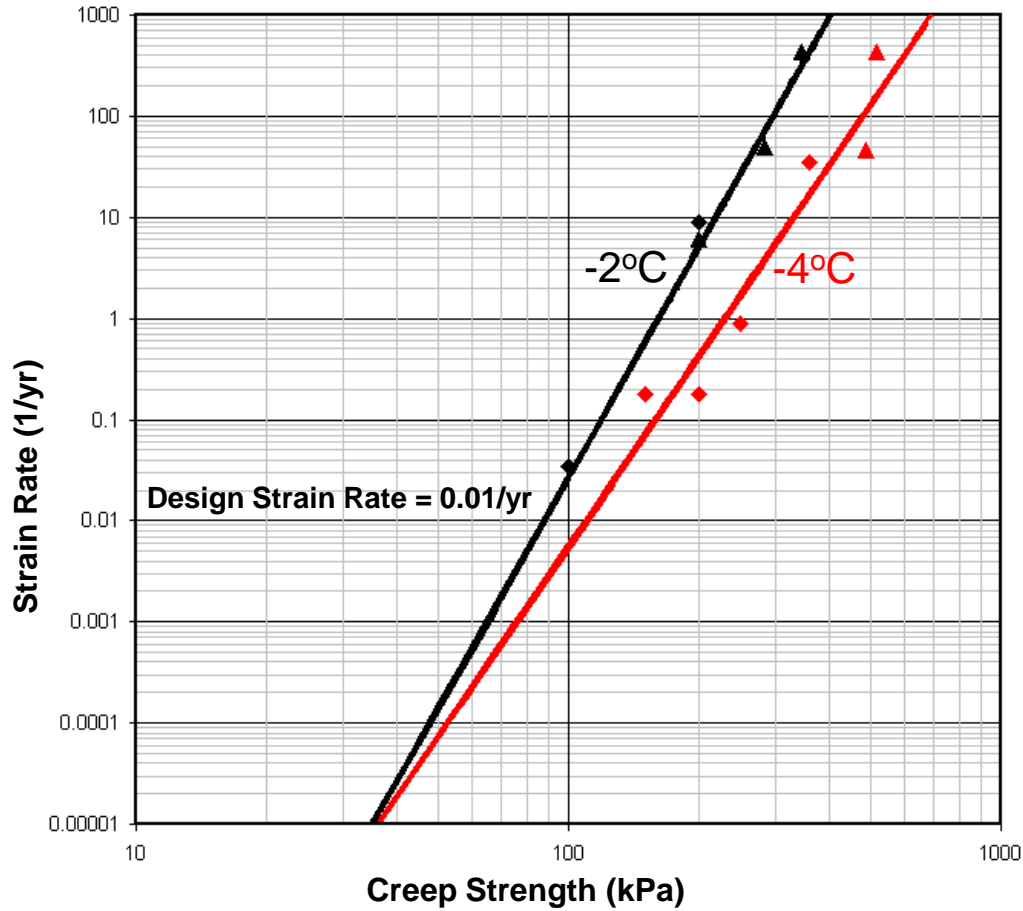
PROJECT		DIAVIK DIAMOND MINES INC. NORTH COUNTRY ROCK PILE NWT		
TITLE		ICE-RICH SOIL CREEP STRENGTH		
PROJECT No. 09-1328-0006		FILE No.		
DESIGN	JFC	24APR09	SCALE NTS	REV.
CADD	BEW	17SEP09		
CHECK	--	--	FIGURE 4	
REVIEW

▲	Constant Stress (- 2°C)
◆	Constant Strain (- 2°C)
▲	Constant Stress (- 4°C)
◆	Constant Strain (- 4°C)

creep strength laboratory test data from NKSL (2001)

Limiting creep rate criteria was used in the assessment of the stability analyses for areas of the NCRP with ice rich foundations (Appendix C). A limiting creep rate of 0.01 mm/year was used for the analyses. The results indicated that the side slopes must be no steeper than 2H:1V and 3H:1V for ice-rich foundation conditions at -4°C and -2°C, respectively, to meet the creep rate criteria. The areas of the NCRP where the side slopes will be re-sloped to 3H:1V slopes for placement for the cover system satisfy the creep rate criteria. At the southeast and northwest corners of the NCRP where the design section does not include re-sloping the side slopes, the maximum overall slope angles are approximately 2.8H:1V and 2.6H:1V, respectively. No large displacements have been observed to date in these areas. Creep movements higher than 0.01 mm/year may occur at the lower benches at these areas if the ice-rich foundation temperature is near -2°C; however, rapid run-out failures are not expected. Some tolerable movement is therefore expected, and monitoring has been specified.

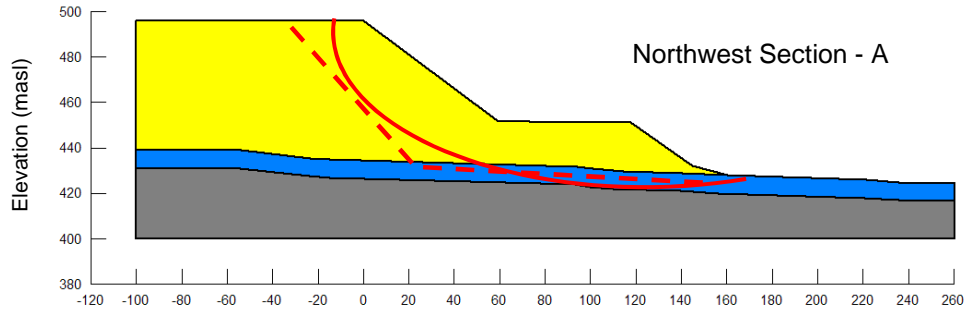
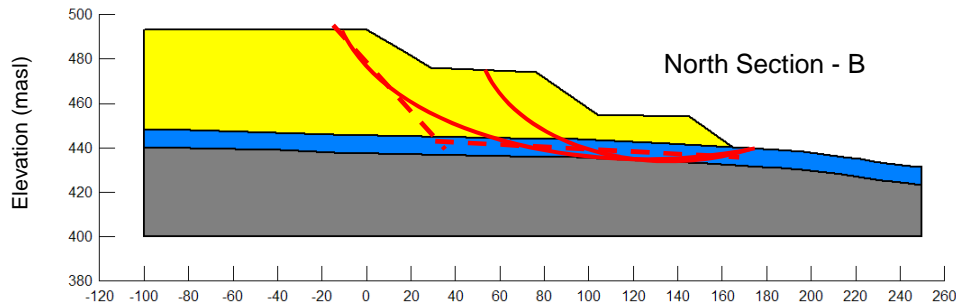
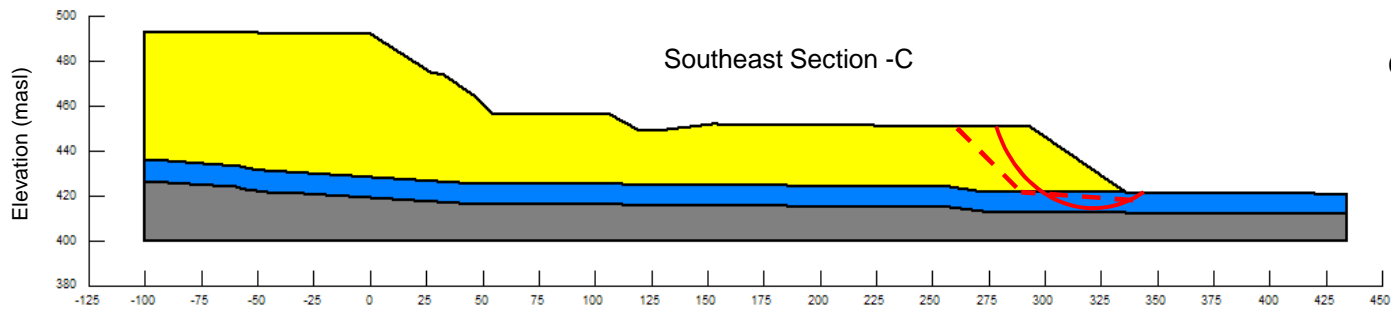
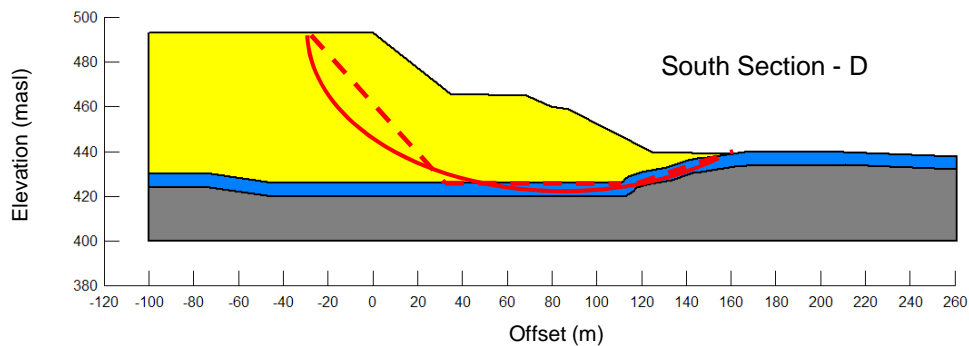
FIGURE 5

Section Location		North	Northwest	South	South	South	South	South	South
		FoS for Static and (Pseudo-Static) Loading Conditions							
Foundation Condition		Circ.	Block	Circ.	Block	Circ.	Block	Circ.	Block
Ice rich	Partly Thawed	1.6 (1.4)	2.0 (1.9)	1.5 (1.5)	1.8 (1.7)	2.6 (2.4)	2.5 (2.4)	1.4 (1.4)	1.5 (1.4)
	Thawed	1.5 (1.4)	2.1 (2.0)	1.5 (1.5)	2.0 (1.8)	2.7 (2.5)	2.9 (2.7)	1.4 (1.4)	1.5 (1.4)
Ice poor	Frozen	3.6 (3.3)	3.7 (3.4)	2.7 (2.6)	2.7 (2.5)	3.0 (2.8)	3.0 (2.8)	3.1 (3.0)	3.4 (3.3)
	Thawed	1.7 (1.6)	2.2 (2.1)	1.7 (1.6)	2.1 (2.0)	3.1 (2.9)	3.1 (2.9)	1.6 (1.5)	1.6 (1.5)

typical circular type failure surface
 typical block type failure surface

The sensitivity analyses in Appendix C indicate that side slope angles of 1.3H:1V or shallower will meet or exceed the minimum design criteria factor of safety for slope stability for the range of foundation conditions under both static and pseudo-static loading conditions. The NCRP closure design sections have 3H:1V and 1.3H:1V slopes; therefore the NCRP closure design sections satisfy the design criteria factor of safety.

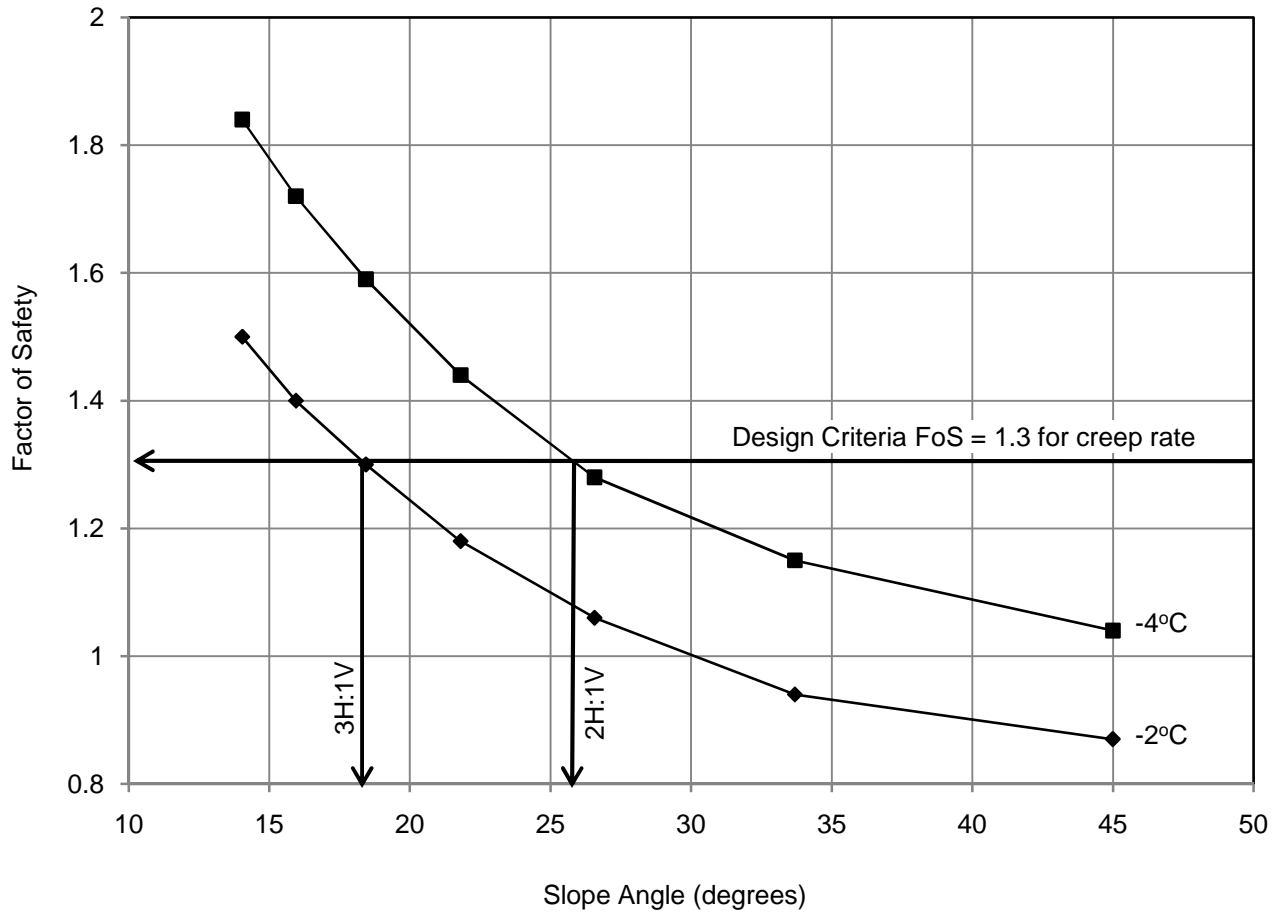
PROJECT		DIAVIK DIAMOND MINES INC. NORTH COUNTRY ROCK PILE NWT		
TITLE		STABILITY ANALYSIS SENSITIVITY SLOPE ANGLE		
PROJECT No. 09-1328-0006		FILE No.		
DESIGN	BEW	16JUN09	SCALE NTS	REV.
CADD	BEW	17SEP09		
CHECK	--	--		
REVIEW

Calculated values of FoS are for rock pile on ice rich permafrost soils.
